REPLACEMENT RESERVE REPORT FY 2016 SHEARWATER CONDOMINIUM ASSOCIATION

SHEARWATER CONDOMINIUM ASSOCIATION

ANNAPOLIS, MARYLAND

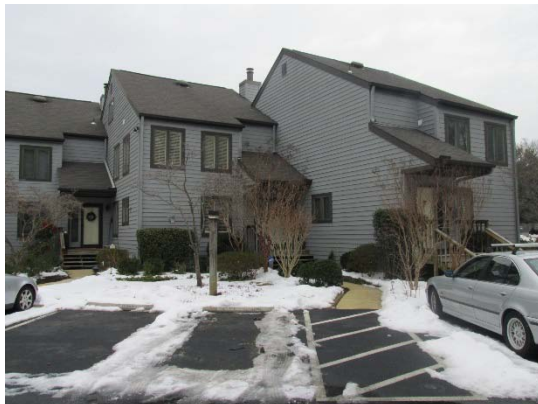
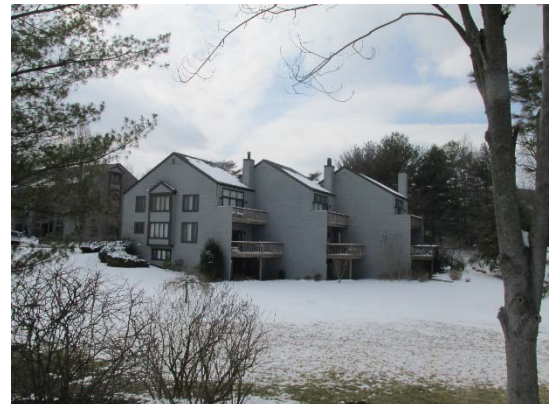
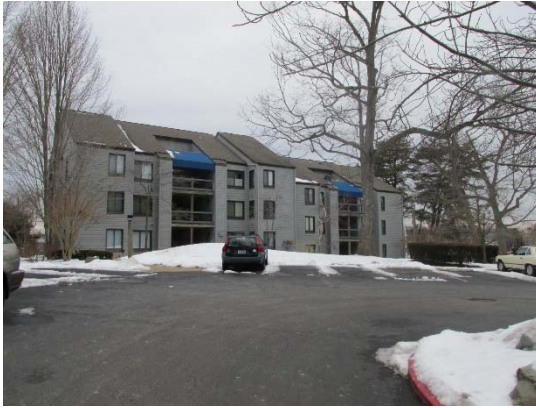
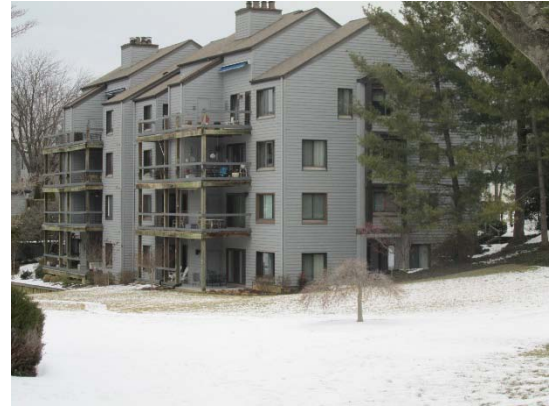
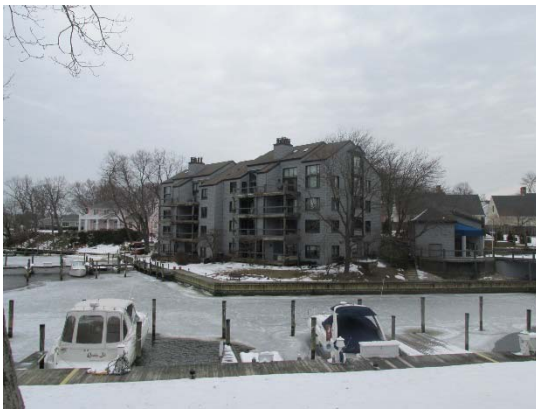
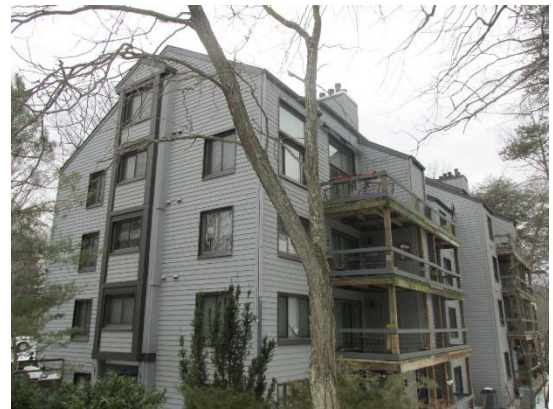
The community's residences are in one townhome building and 16 multi-family stairway/buildings. Elevations are shown below. The first two pictures are of the single townhome building while the last four are of the multi-family buildings.

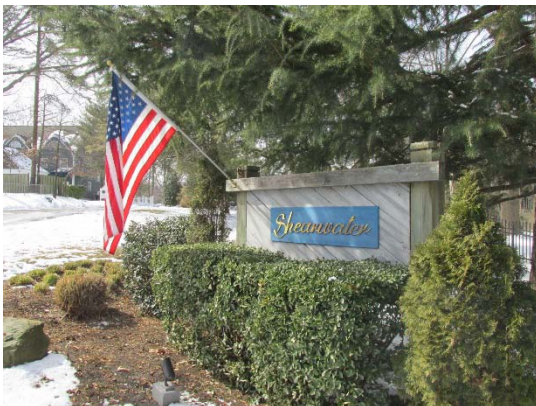
Entry Signage. The Association maintains two wood community identification signs on either side of the entry road which is a continuation of Madison Street where it intersects with Boucher Avenue.

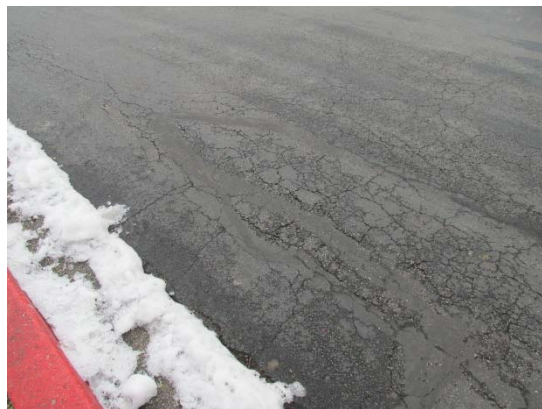
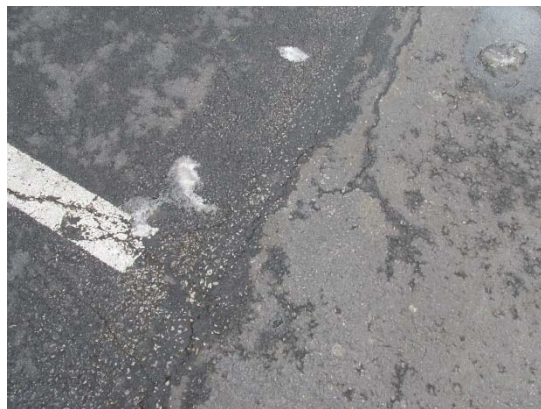
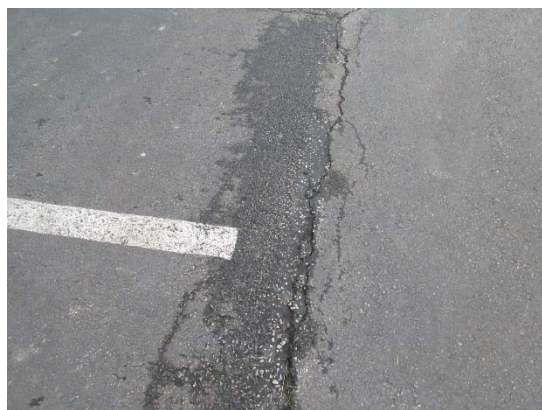
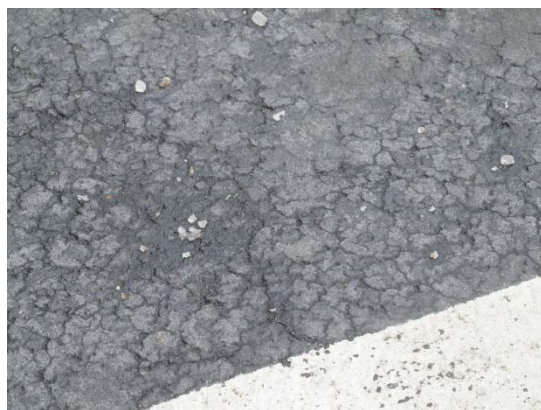
Asphalt Pavement. The Association is responsible for the roadways and parking areas within the community; other streets, such as Boucher Avenue and Madison Street, are maintained by the City of Annapolis. In general, the Association's asphalt pavements are in good condition, with minor cracking. The Analyst recommends application of a seal coat in 2015 and 2021 and with a mill and overlay 2027.

As a rule of thumb, asphalt should be overlaid when approximately 5% of the surface area is cracked or otherwise deteriorated. The normal service life of asphalt pavement is typically 18 to 20 years.

In order to maintain the condition of the pavement throughout the community and to ensure the longest life of the asphalt, we recommend a systematic and comprehensive maintenance program that includes:

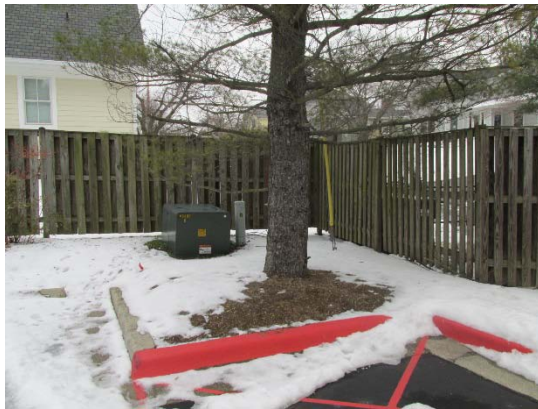
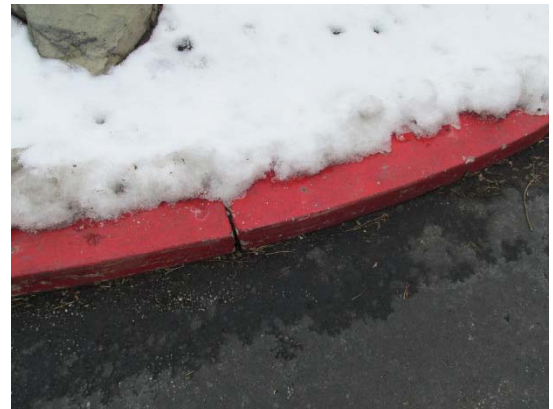
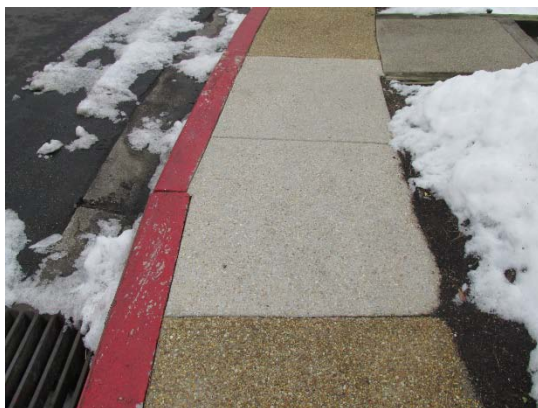
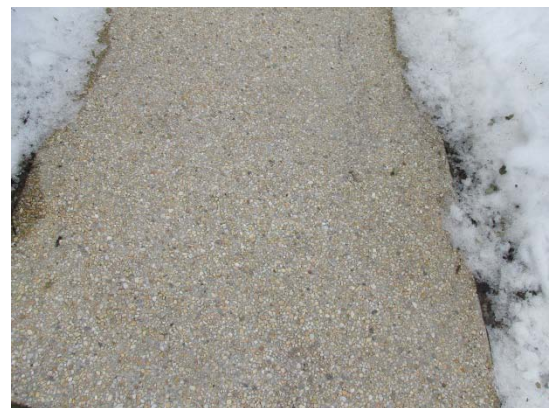
Concrete Work. The concrete work includes the community curbs, sidewalks, leadwalks, steps, stoops, and other flatwork. The sidewalks, leadwalks, and stoops are an exposed aggregate where the stone is a pea gravel mixture. We have modeled for curb replacement when the asphalt pavement is overlaid. The steps are located at the building entries leading to a basement lobby where access is for the utility rooms. The overall condition of the concrete work is good.

The standards we use for recommending replacement are as follows:

- Trip hazard, ½ inch height difference.
- Severe cracking.
- Severe spalling and scale.
- Uneven riser heights on steps.
- Steps with risers in excess of 8¼ inches.

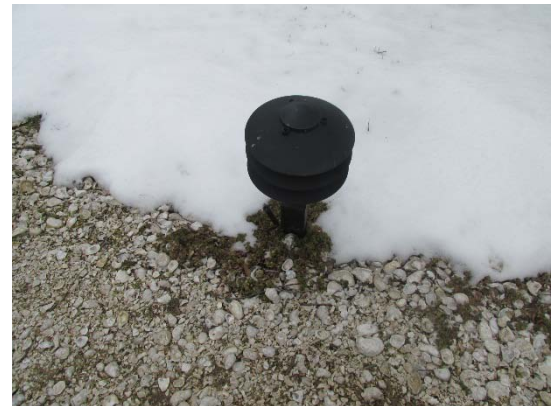
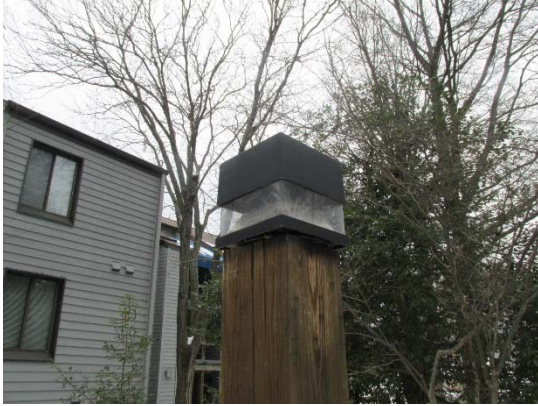
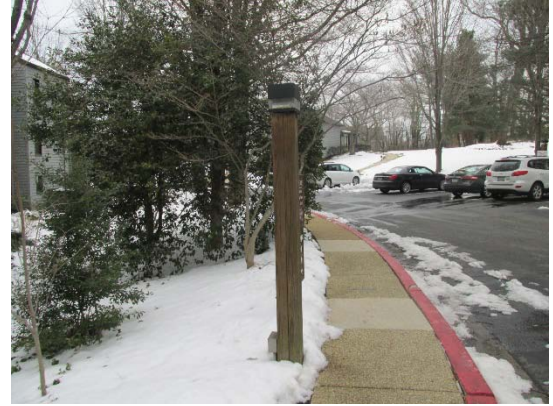
Site Lighting. The Association is responsible for the operation of the facility's landscape, walkway, and street lights. The lighting system was not on at the time of our site visit. But because of its signs of aging, the Analyst shows funding in this study for replacement by the end of the 2021 fiscal year.

This study assumes replacement of the light fixtures every 15 to 20 years, and pole replacement every 30 to 40 years. When the light poles are replaced, we assume that the underground wiring will also be replaced.

When a whole-scale lighting replacement project is called for, we recommend consulting with a lighting design expert. Many municipalities have design codes, guidelines, and restrictions when it comes to exterior illumination.

In addition, new technology such LED and LIFI among others should be evaluated when considering replacement.

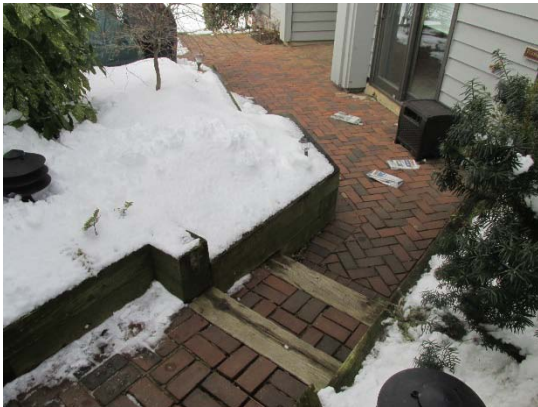
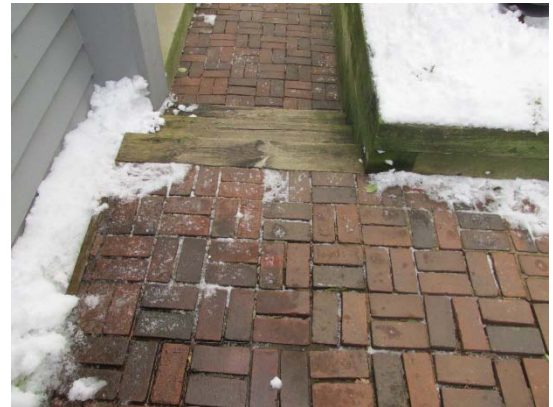
Brick Pavers. Brick pavers provide solid, decorative, and renewable surfaces that are part of the community's sidewalks. The overall condition of the unit pavers is good with areas of defects consistent with the age of their installation. Because of their inter-action with the wood retaining walls and wood steps as well as their age, the pavers are funded for replacement in five years.

Unit pavers have a service life of 30 to 40 years if the system is maintained on a periodic basis. Eventually the system will require a large-scale replacement, identical paver units may not be available and it is recommended that the unit paver system be replaced.

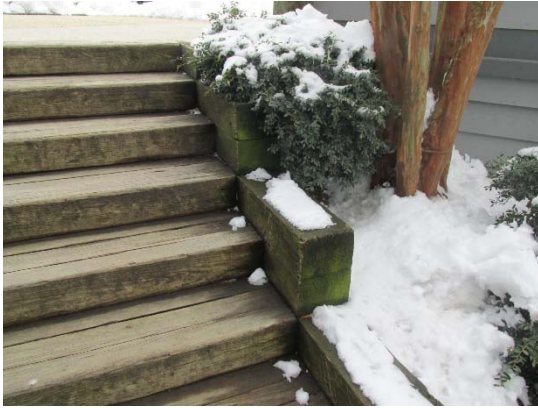
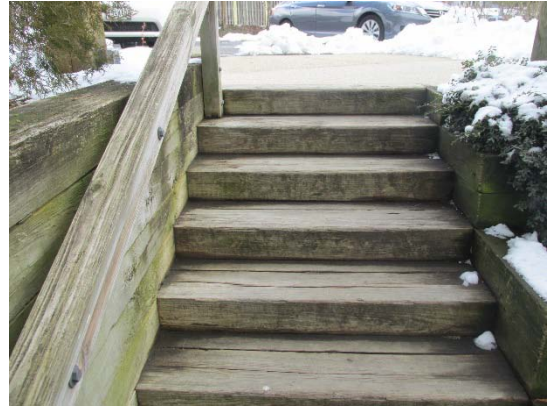
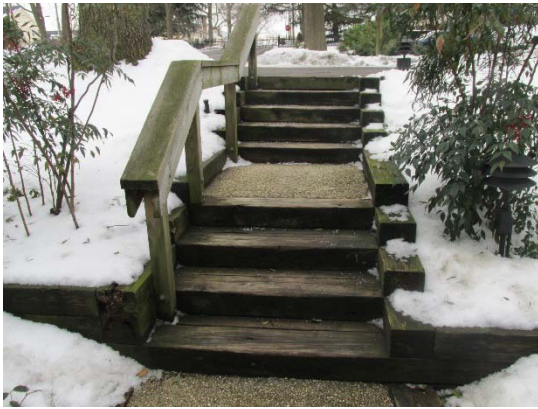
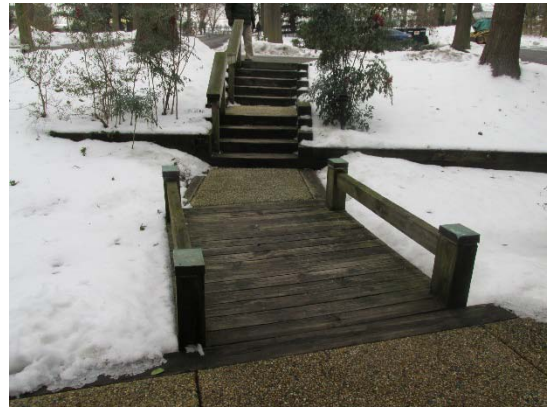
Pressure Treated Wood Steps. The community has a large amount exterior timber steps that are constructed from pressure treated wood. The general condition of the steps is poor because of the normal signs of aging. Like the Brick pavers and the Wood retaining walls, this component is funded for replacement in five years.

Along with the next component; the Analyst recommends the use of an engineered, segmental block system for these steps as well as the inter-connected retaining walls.

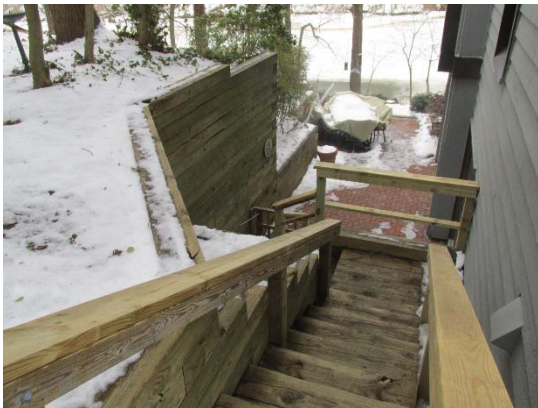
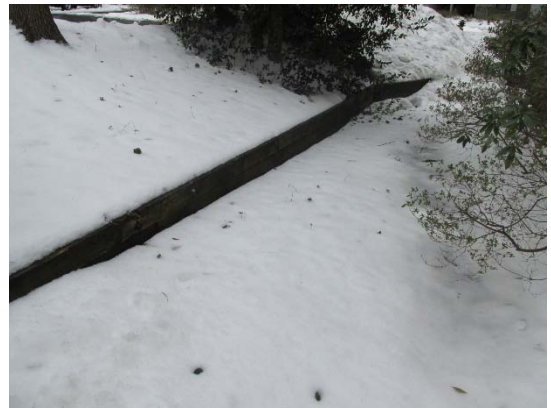
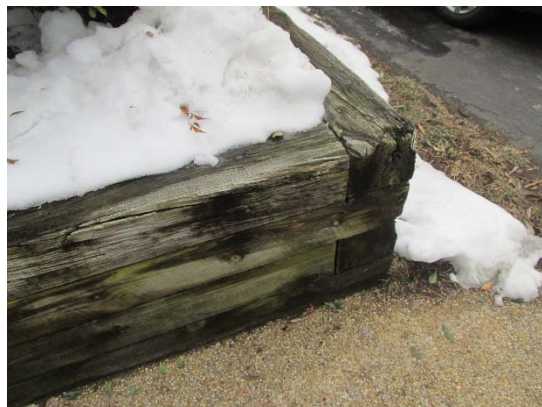
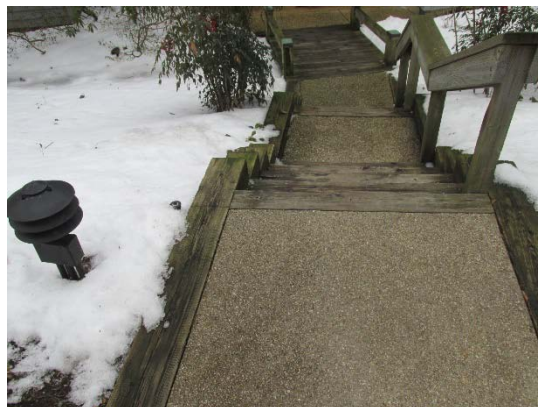
Retaining Walls. The Association maintains several wood retaining walls. The retaining walls are in poor condition.

As mentioned above, the Analyst recommends the use of an engineered segmental block retaining wall system as described in the following text.

Retaining walls in general are designed to provide slope stabilization and soil retention by means of a structural system. Typically, walls that are three feet high or more require some level of design.

Movement and displacement of any retaining wall is a sign of general settlement or failure. This typically is in the form of leaning and bowing, and can involve the entire wall or localized sections of the wall. Typically, these types of movements are gradual and may require the replacement of the wall. Movement of retaining walls located near other buildings or structures may negatively affect the stability of the adjacent structure. These conditions can become extremely costly if not properly identified, monitored, and addressed.

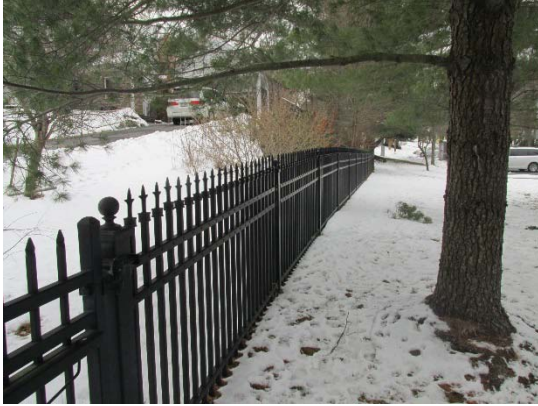
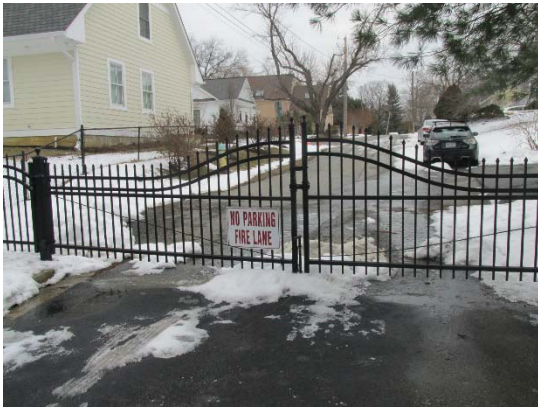
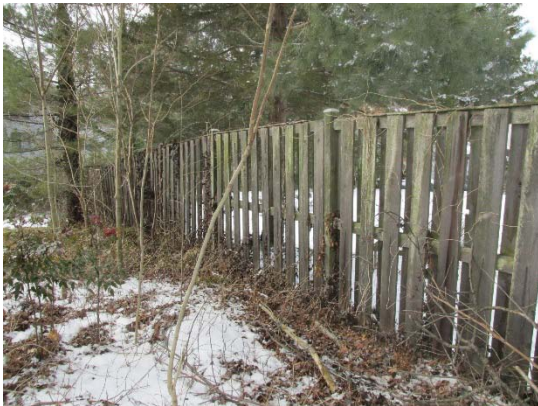
Fencing. The Association maintains wood and aluminum fencing that is in a generally good condition. Fencing systems have a large number of configurations and finishes that can usually be repaired as a maintenance activity by replacing individual components as they become damaged or weathered.

Protection from string machine damage during lawn maintenance can extend the useful life of some fence types. Protection from this type of damage is typically provided by applying herbicides around post bases or installing protective sheathing.

Pressure treated wood fencing should be cleaned and sealed every year or two. Typically the least cost fencing option, this type of fence can last 15 to 20 years if maintained properly.

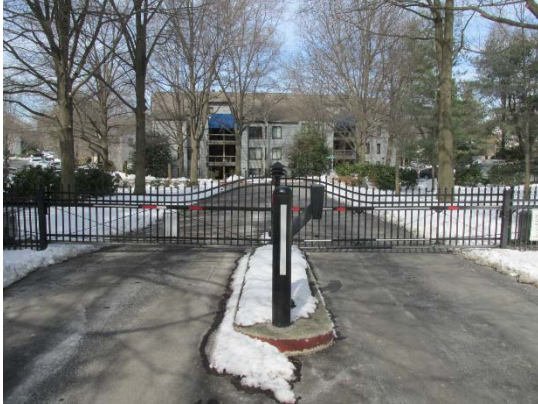
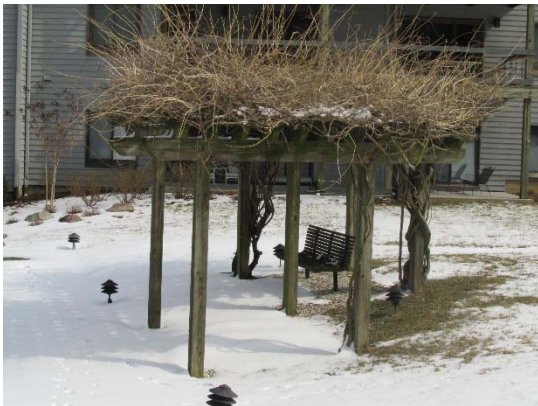
Miscellaneous Site Components. Not mentioned above are the following components such as; the entry gate, its key pad, a wood trellis, a wood shed, and an oyster shell path.

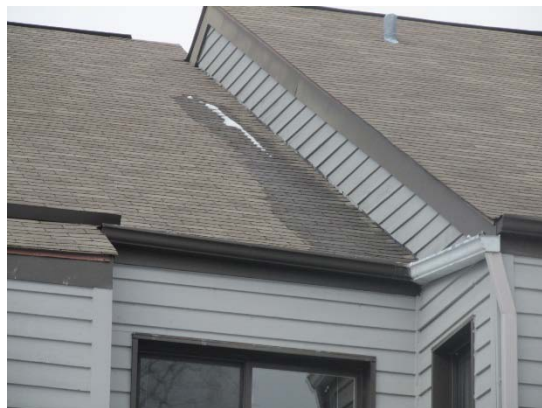
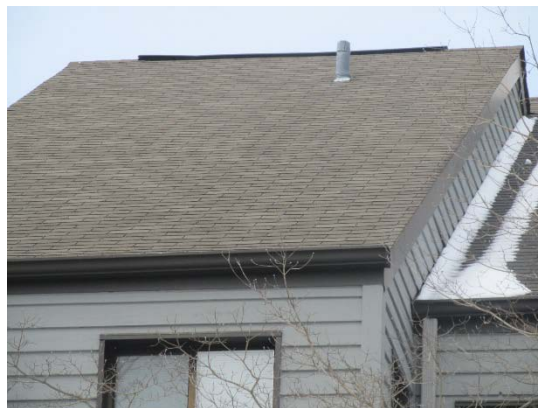
The condominium buildings' shingles were replaced in 2004 while the townhomes building's shingles were replaced in 2000. The Analyst has funded for the shingles on the pool building and the racquetball building to be replaced in 2017 or 2018.

Asphalt shingle roofs can have a useful life of 20 to 50 years depending on the weight and quality of the shingle. Weathered, curled, and missing shingles are all indications that the shingles may be nearing the end of their useful life. The shingles used by the Association on the Condominium and Townhome buildings are 25 year-life ones as are being funded for the other two buildings.

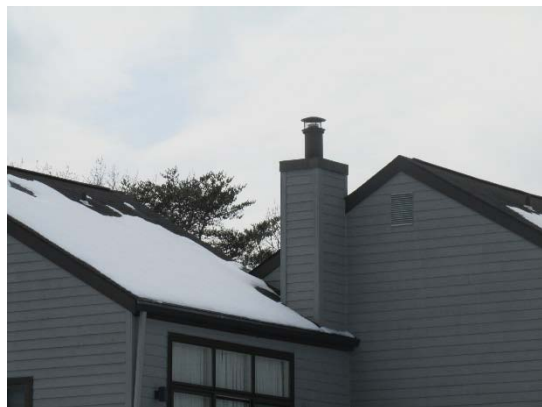
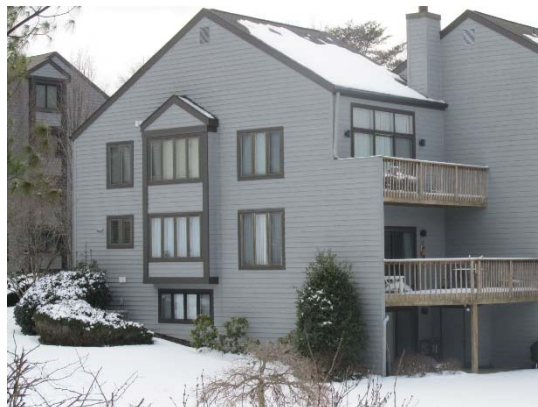
Chimney Caps. There are metal caps on the condominium and townhome buildings' chimneys. The chimney caps are in fair condition based on their age. Chimney caps have a typical service life of 30 years.

All chimney caps were observed from the ground level.

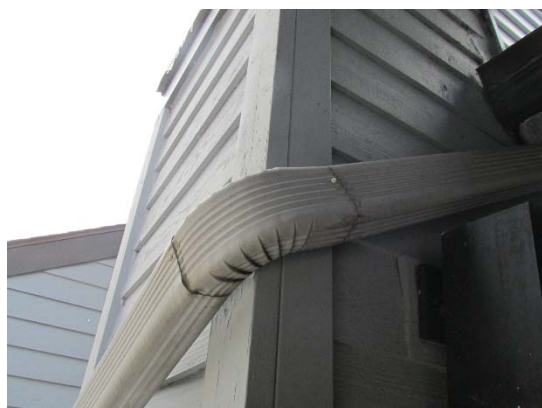
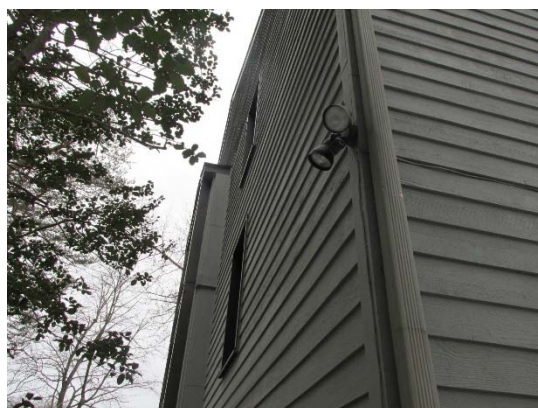
Gutters and Downspouts. The buildings have aluminum gutters and downspouts. The gutters and downspouts are in good condition.

A gutter and downspout system will remove rainwater from the area of the building roof, siding, and foundation. This will protect building's exterior surfaces from water damage. Gutters should run the full length of all drip edges of the building roof. Even with full gutters, it is important to inspect the function of the gutters during heavy rain to identify any deficiencies. It may be necessary to periodically adjust the slope of sections, repair connections, replace hangers, and install shrouds to the gutters. Downspouts should be securely attached to the side of the structure. Any broken straps should be replaced. The area of the outlet should be inspected to promote run-off in the desired direction. Long straight runs should have an elbow at the bottom. Splash blocks should be installed to fray the water out-letting from the downspout.

It is recommended that all gutters be cleaned at least twice each year. If there are a large number of trees located close to a building, consider installing a gutter debris shield that will let water into the gutters but will filter out leaves, twigs, and other debris.

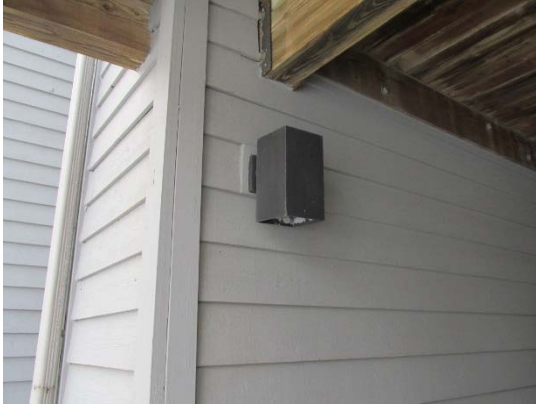
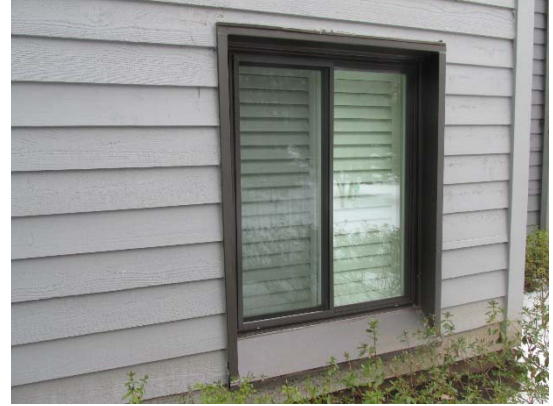
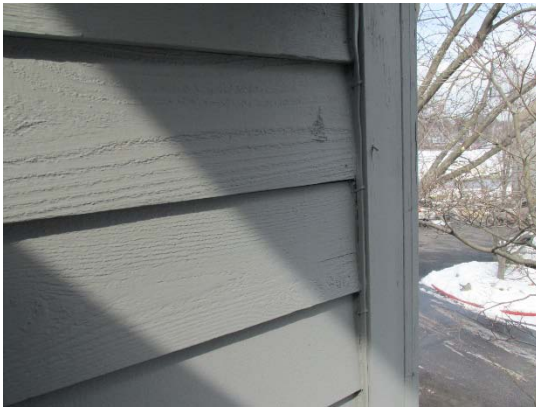
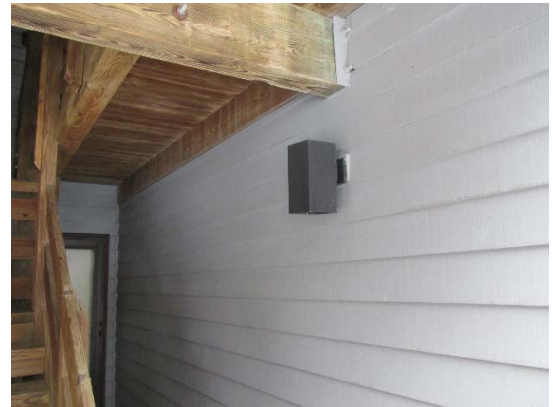
Siding and Trim. The exteriors of all the buildings have cedar siding and trim. That is what the Analyst has used in the funding. It is recommended by the Analyst; that at the time of replacement, the use of vinyl or another synthetic material be considered.

Wooden exterior materials are typically repaired as needed during normal painting cycles. Painting cycles for wooden exteriors vary between five and ten years depending on the grade of wood and the quality of the materials and finish work. In this study, we have modeled for incremental wood material replacement to coincide with the painting cycle of the facility.

As an alternative to high-maintenance materials, the Association may want to consider replacements using low maintenance synthetic or cementitious materials. For additional consideration, please see the related articles "Alternative Trim Materials - A Replacement for Wood Trim?" and "An Examination of New Materials - Cement Fiber Composites" on our web site at <http://mdareserves.com/resources/links/building-exterior>.

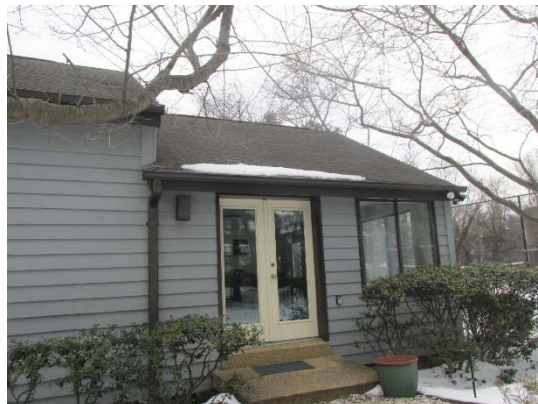
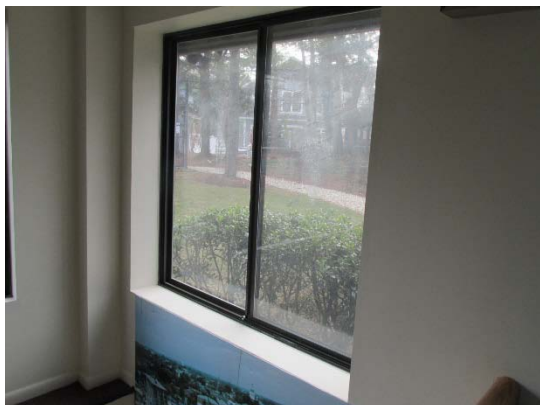
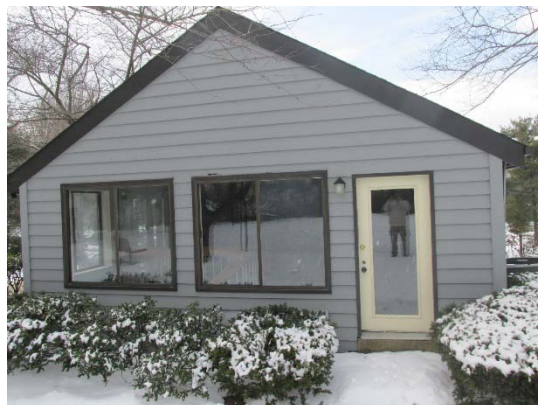
Windows and Doors. The Association is responsible for the common windows (on the Racquetball building) and exterior doors of that facility and the common doors of the multi-family buildings. The individual owners are responsible for the windows and doors attributed to their unit.

The windows are in poor condition and the common doors are in fair condition.

For Associations where the unit owner is responsible for the replacement of their own windows and exterior doors, we recommend for the Association consider offering the unit owners an option to have their replacements performed in conjunction with the Association's work. This can be performed either by separate agreement between the unit owner and the Association's selected contractor or by back charging the unit owner.

In general, we recommend coordinating the replacement of these units with other exterior work, such as siding and roof replacements. The weather tightness of the building envelope often requires transitional flashing and caulking that should be performed in coordination with each other. Warranties and advantages in 'economy of scale' can often result in lower overall replacement costs and results that are more reliable. Lastly, coordinated replacements offer the opportunity to correct initial construction defects and improve the effectiveness of details with improved construction techniques and materials.

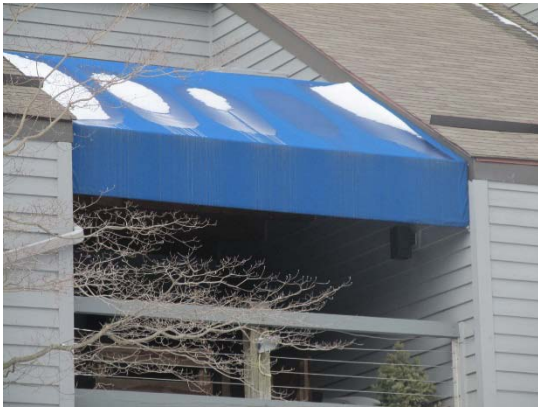
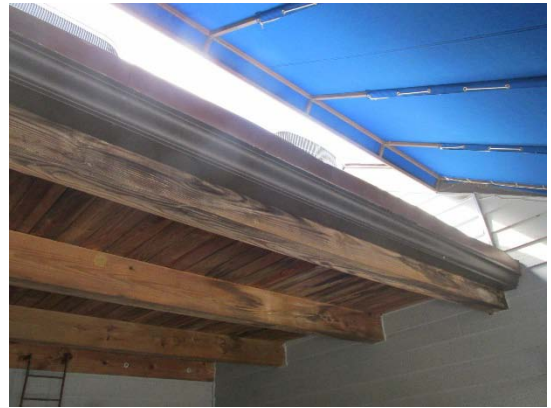
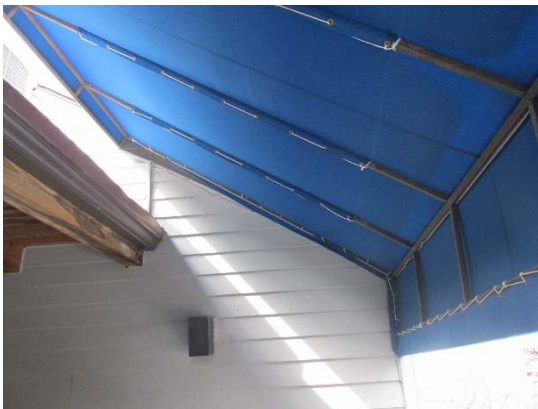
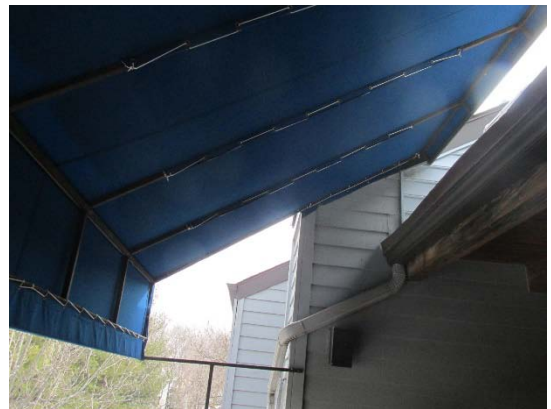
Entrance Awnings. The Association maintains a fabric cover on metal frame at each of the multi-family building entrance stair landings. The overall condition is good. We have assumed a service life of 10 years for the fabric cover and 20 years for the metal framing.

To prolong the useful life of the fabric cover, we recommend periodic cleaning and the application of an appropriate sealant.

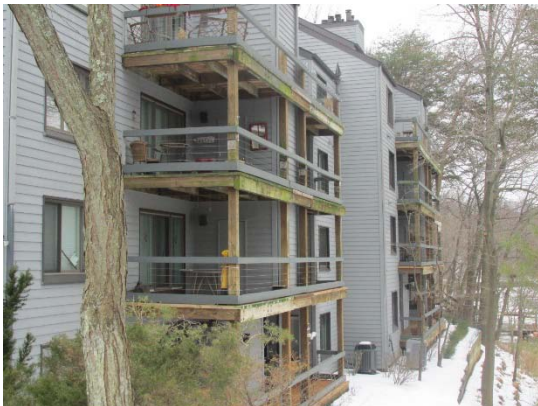
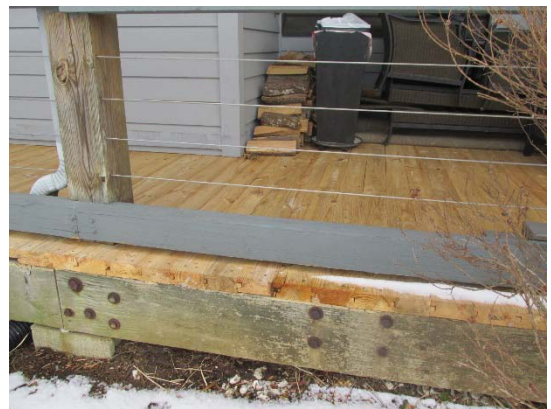
Wood Decks. The wooden decks of the community are maintained by the Association. They are in excellent condition after having been recently replaced. Because of the community's proximity to a tributary of the Chesapeake Bay, special wood was used without the usual chemicals seen in wood treatment.

We recommend for the Association implement an annual inspection program. We also recommend power washing every two to three years. Installation of carpet or other water trapping coverings should be prohibited and potted plants should be placed on raised feet to allow for proper air circulation and drying of wooden components.

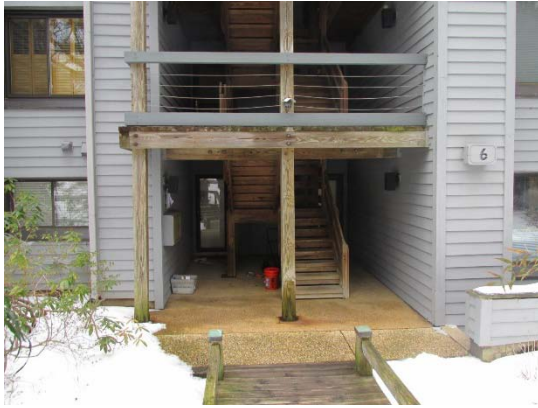
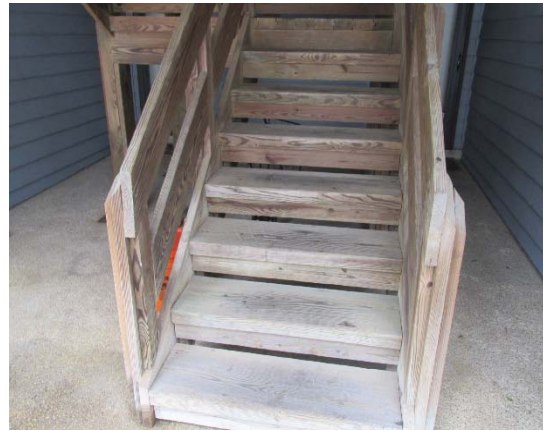
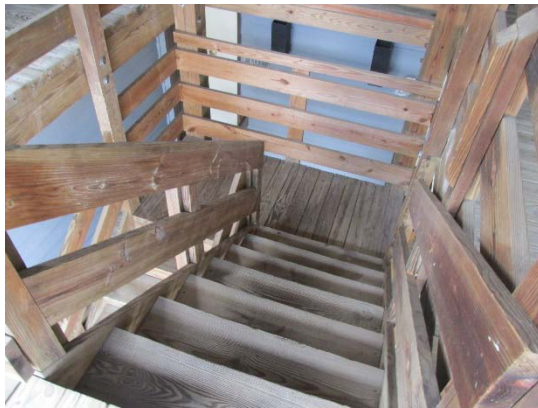
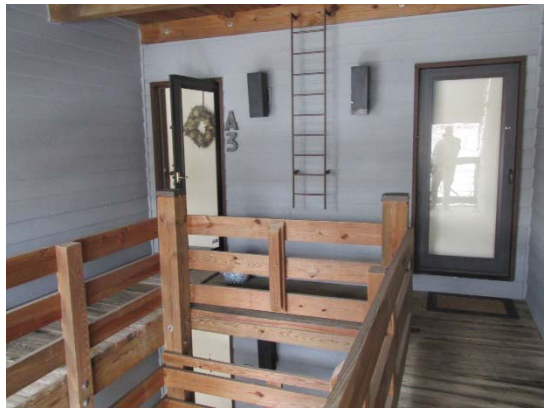
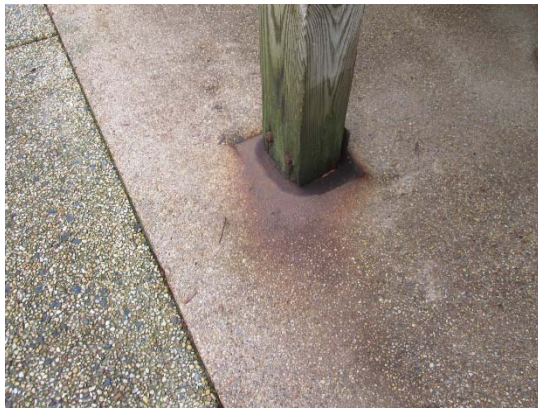
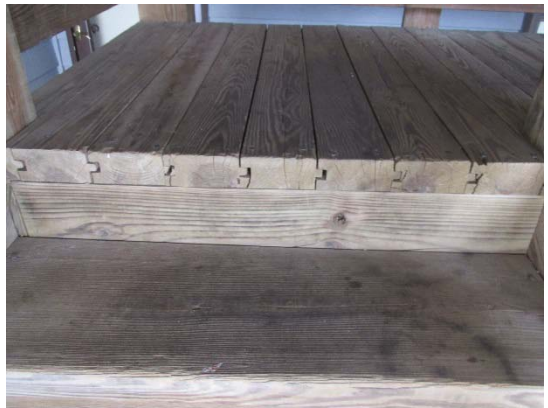
Exterior Wood Stairs. The exterior stairs consist of wood posts, treads, and landings with wood stringers. The stairs are in good condition.

The wood in the exterior stairs expands and contracts with changes in temperature and moisture levels within the wood, leading to cracks. Untreated, these cracks will expand and can lead to the development of rot within the wood.

It is recommended that the Association inspect all stairs at least once each year. All areas with moderate cracking or rot should be replaced. Areas covered with mold should be cleaned and treated.

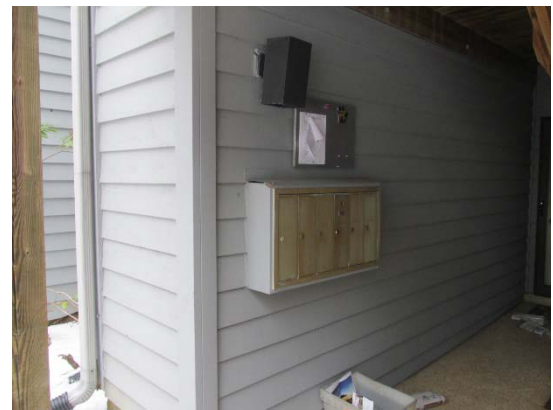
Mailboxes. The cluster mailboxes located throughout the community are in good condition. Mailboxes should be maintained to the extent that rust does not develop on the structure or pedestal. All mail slot doors remain intact and hinges and locks remain operable. Our replacement estimate assumes that these units will be replaced with fiberglass or composite units.

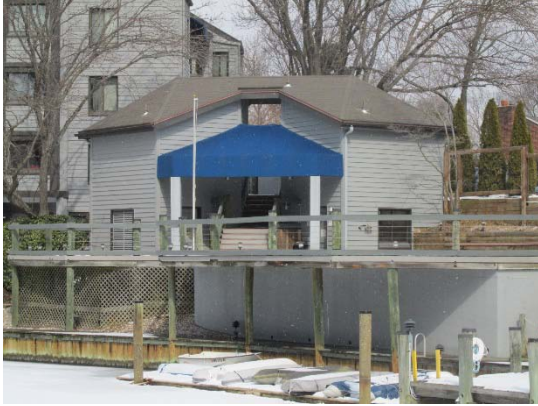
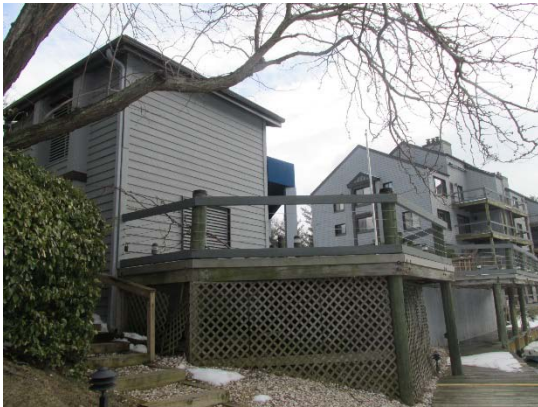
Pool Building & Pool. The community operates a pool building, a concrete deck, a wood deck, and outdoor pool of concrete construction. Listed below are the major components of the pool facilities:

The pool was winterized at the time of inspection and is reported to be in good condition.

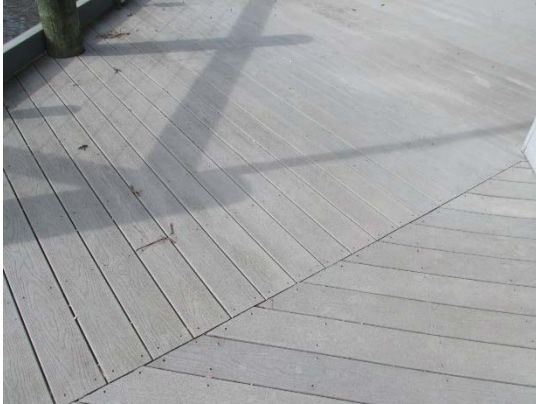
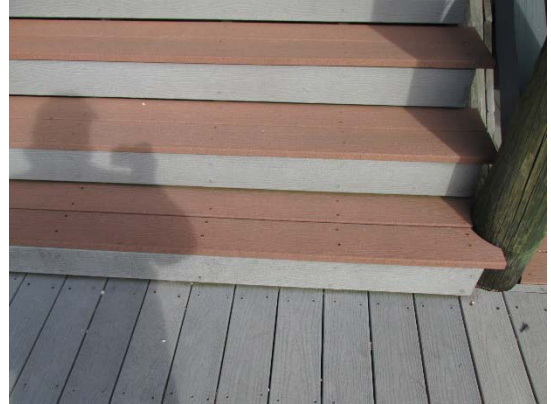
New deck surface.

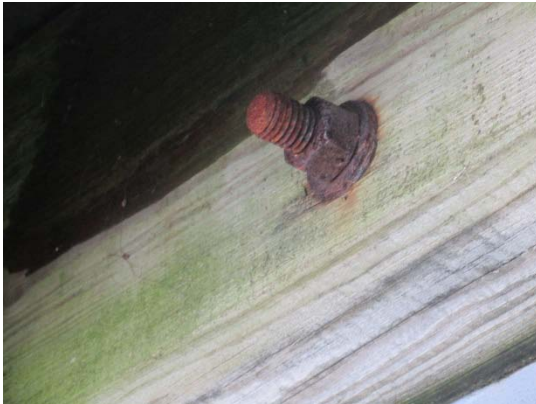
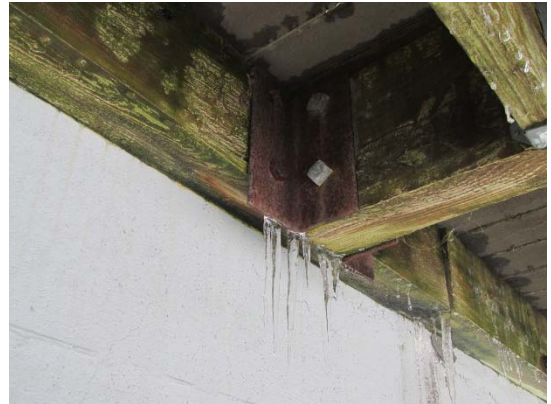
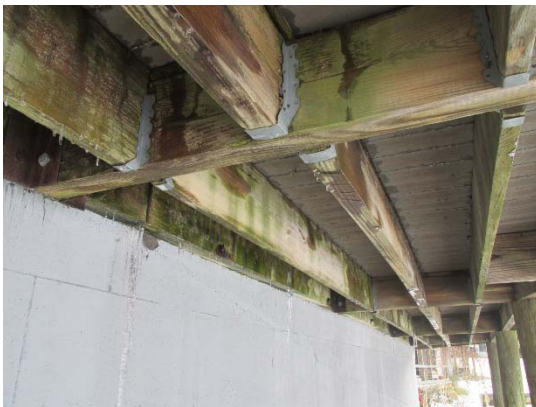
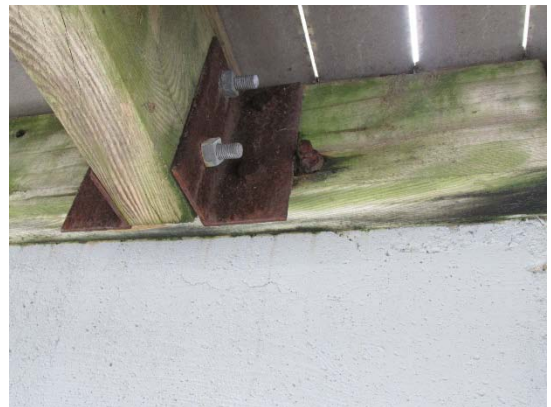
Deck structure.

- Pool Deck. The pool has a concrete deck and a wood deck of new composite decking over an older oversized timber framing structure. As shown in the pictures below, there are two serious problems with the wood deck: the fasteners of the deck's structure appear to be seriously rusted and the timbers are showing signs their remaining life cycle is limited. With all this in mind, the Analyst added a new component to address the structure fastening and funded for the Remaining Economic Life cycles in the same (15th) year.
- Whitecoat. See above.
- Waterline Tile. See above.
- Coping. See above.
- Pump and Filter System. These components are funded for their replacement in the near future.

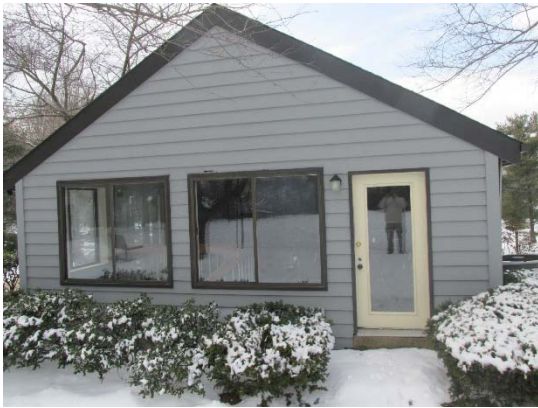
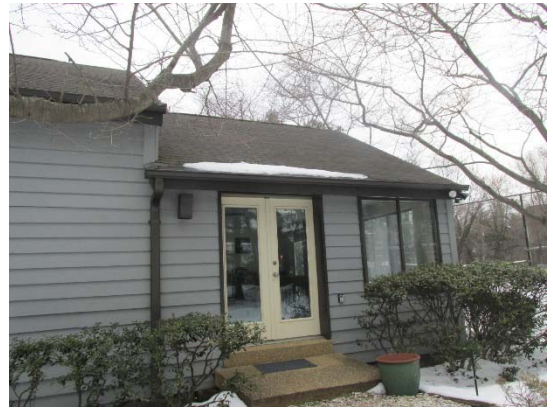
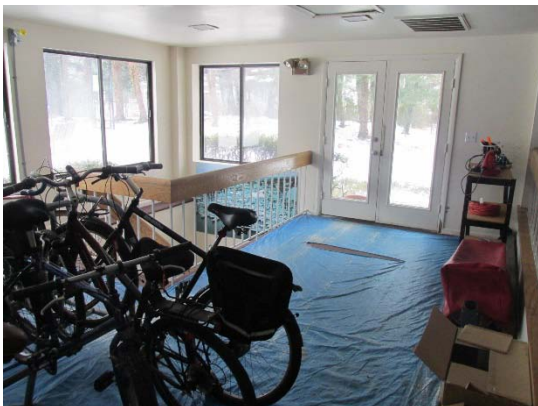
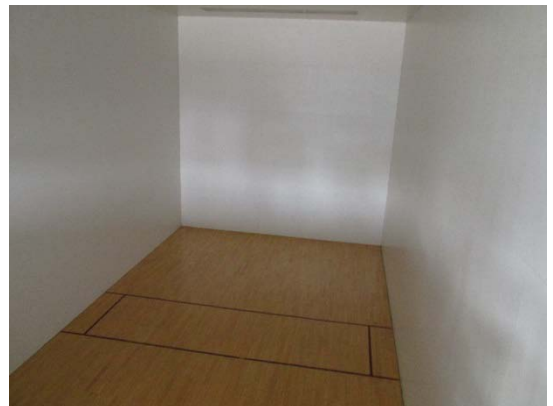
The racquetball building is underutilized because of its decrepit condition. It appears to the Analyst that the Association shares this assessment as published in a study by Association Board of Directors Carol Schaake and Larry Birch titled "Racquetball Court Project."

The Remaining Economic Life cycles are based on this study.

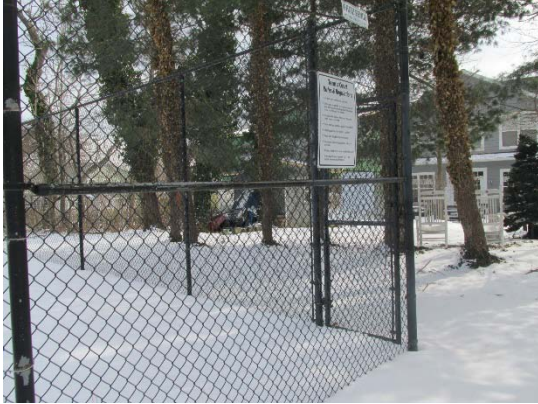
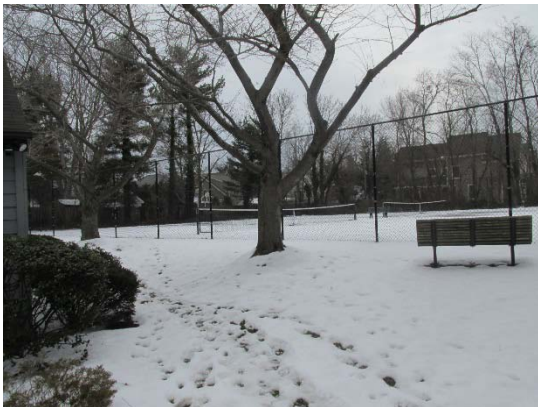
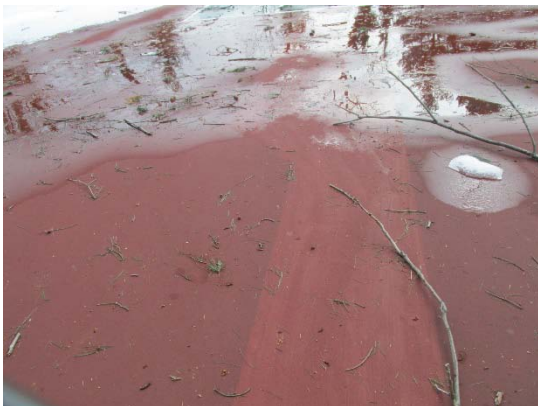
The community maintains two tennis courts. The overall condition of these courts was not to be determined because of a significant snow cover.

The funding information is based on information from the Association as well as the Analyst being able to see some parts of the components.

Listed below are the major components of the tennis court facilities:

- Asphalt Pavement (base layer). We have assumed a service life of 20 to 30 years for the asphalt base layer.

- Color Coat (surface layer). Annual cleaning is recommended to maintain the surface of the court. The base of a tennis court is subject to cracking and low spots known as “birdbaths” that can occur from weather and earth movement. A program to address cracks as they appear will help to prolong the useful life of the color coat. We have assumed a service life of five to ten years for the color coat.

- Fencing. We have assumed that the fencing will be replaced when the asphalt pavement is replaced. Posts and fencing should be inspected, repaired, and painted as needed to prolong their economic life. Periodic inspection of the posts, gates, hinges, and latches is also recommended, and it is important that posts and footings be protected to prevent soil erosion. In addition, care should be taken so that damage from string trimmers is minimized.

- Net Posts. We have assumed that the new posts will be replaced when the asphalt pavement is replaced.
